Manhole Inspection Summary

Manhole # S23O1_006MH

Insp Date: **6/23/08 10:15 AM**

Location Address: **3360 Annapolis Rd.**

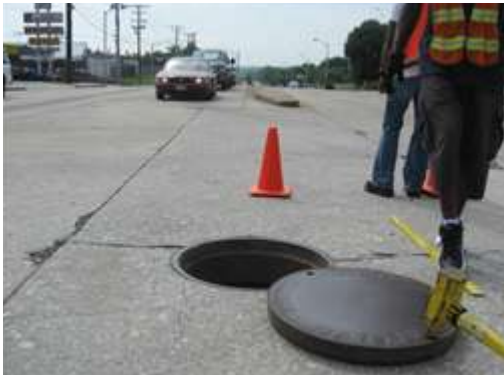
Location View

3360 Annapolis Rd.

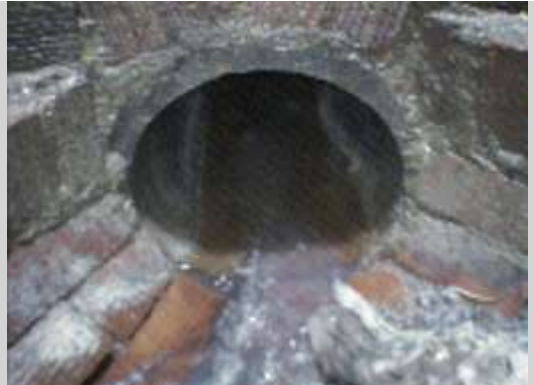
12 O'Clock Outflow

10 in. Circular Gravity Sewer
Pipe Out @ 12 O'Clock

Pipe Height: **10.8** (in.) Rod and Bar (Angled)
Pipe Material: **Clay** ☐ Pipe Lined
Invert Depth: **15.84** (ft.) Flow Characteristics: **Fast**
Deposits: ☒ None ☐ Mud ☐ Gravy ☐ Debris ☐ Grease
Silt Depth: (in.) Deposits Extent:
Infiltration: **None** Pipe Seal Cond: **Sound**

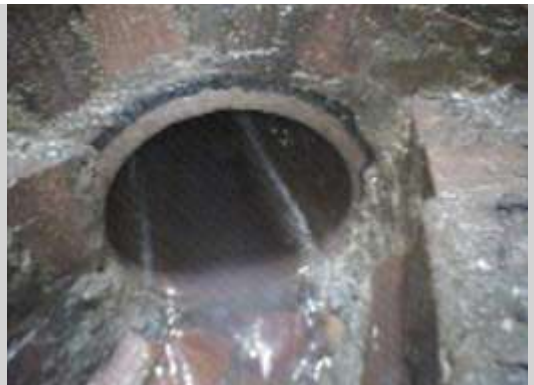
2 O'Clock Inflow

8 in. Circular Gravity Sewer
Pipe In @ 2 O'Clock

Pipe Height: **8.4** (in.) Rod and Bar (Angled)
Pipe Material: **Clay** ☐ Pipe Lined
Invert Depth: **15.48** (ft.) Flow Characteristics: **Fast**
Deposits: ☒ None ☐ Mud ☐ Gravy ☐ Debris ☐ Grease
Silt Depth: (in.) Deposits Extent:
Infiltration: **None** Pipe Seal Cond: **Sound**

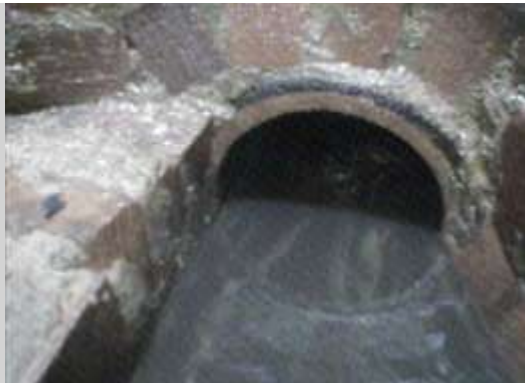
8 O'Clock Inflow

Pipe In @ 8 O'Clock

Pipe Height: **8.4** (in.) Rod and Bar (Angled)

Infiltration: **None** Pipe Seal Cond: **Sound**
